FATIGUE BEHAVIOUR OF A ROLLED AZ31 MAGNESIUM ALLOYS PREPARED BY EP AND BB CONDITIONS

Y. Fouad

Faculty of Engineering and Materials Science, German University in Cairo, Cairo.

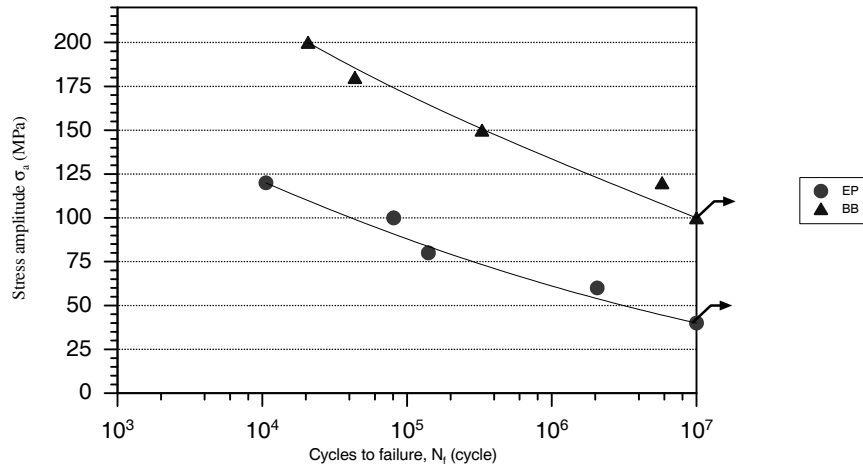
S/N curves for the EP and the BB specimens in laboratory at a stress ratio of -1 and frequency of 50 Hz (rolled magnesium alloy) in laboratory air is shown in Fig. 2. In this figure, for comparison purposes, the S–N curves of the EP and BB specimens are shown respectively. As seen from the figure, the fatigue life of the rolled magnesium alloy of EP specimen is relatively shorter than that of BB specimen. The extent bending in the S–N curve is gentler in the BB specimens than in the EP specimen. Next let us compare the S–N characteristics of the EP and BB specimens. There are great differences in the fatigue lives and in the fatigue limits, especially at higher stress amplitudes, there are differences in the fatigue lives.

Fig.2. S-N curve for rolled AZ31 at EP,BB conditions, rotating beam, R=-1, 50Hz.

4. Subsurface crack initiation occurred at applied stresses at 60 MPa. At BB condition but it can be seen for both 80 and 100 MPa stress for EP condition. The S-N diagram is shown in Fig. 2. It is well known that fatigue limit does not exist in non-ferrous alloys, thus fatigue tests were continued until 10^7 cycles. At EP condition $\sigma = 40$ MPa, fatigue failure did not occur, but non-propagating cracks were observed on the specimen surface. As can be seen in the figure, the present Mg alloy seems to possess a definite fatigue limit, which may be related to the existence of non-propagating cracks. The fracture mode depending

1. Fatigue strength at 10^7 cycles was 100 MPa

- for BB condition with the following preparation condition on ECOROLL instrument using tool type (HG6) at 100 bar (246 N) with feed rate of 0.17 mm/min at 30 rpm. While the fatigue strength at 107 cycles was 40 MPa for EP condition.

2. Fatigue lives and the fatigue limit of BB specimens were higher than those of EP specimens with similar profiles.
 3. Electrical polishing and ball burnishing preparation are very sensitive to working procedure of choosing temperature for EP or in choosing (Feed, Speed and tool head) for BB condition. After many trails to find out the good combination of the three parameters.

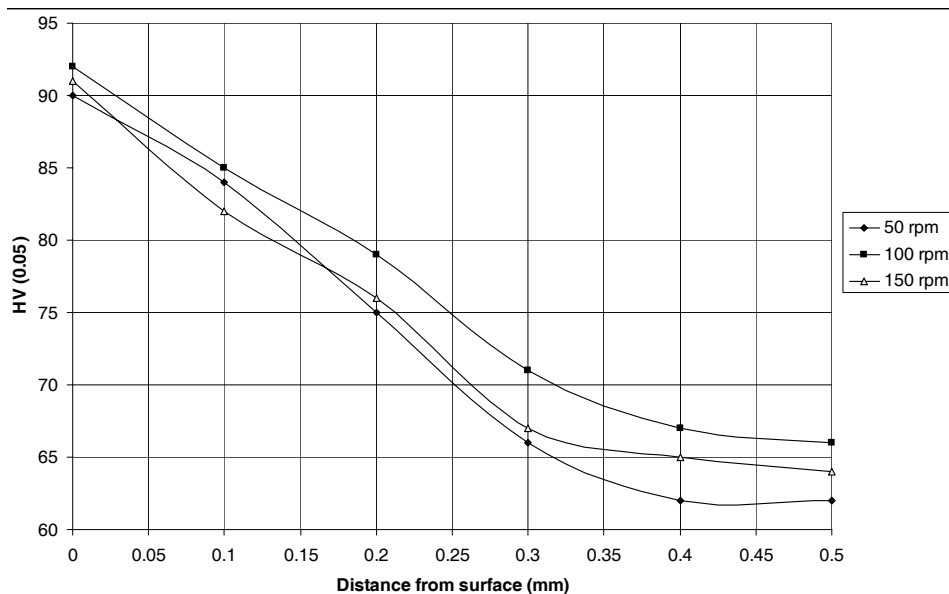
3. 3. A different experiment were used to investigate the best condition for BB (pressure, feed rate, speed) as example for tool HG3 200 bar (123 N) for 50, 100 and 150 rpm. The microhardness measurement from the surface in Fig. 3. Shows that the suitable condition for using 200 bars is 100 rpm for AZ31 as the hardness decreased from the circumference gradually to the center.

Fig. 3. Microhardness profile of AZ31 after BB at 200 bars, 0.17 mm/min at different BB rotation speed.

5. It could be investigate the best condition of BB by examine the surface up to 500 μ m for microhardness value, to choice best values for BB treatment.

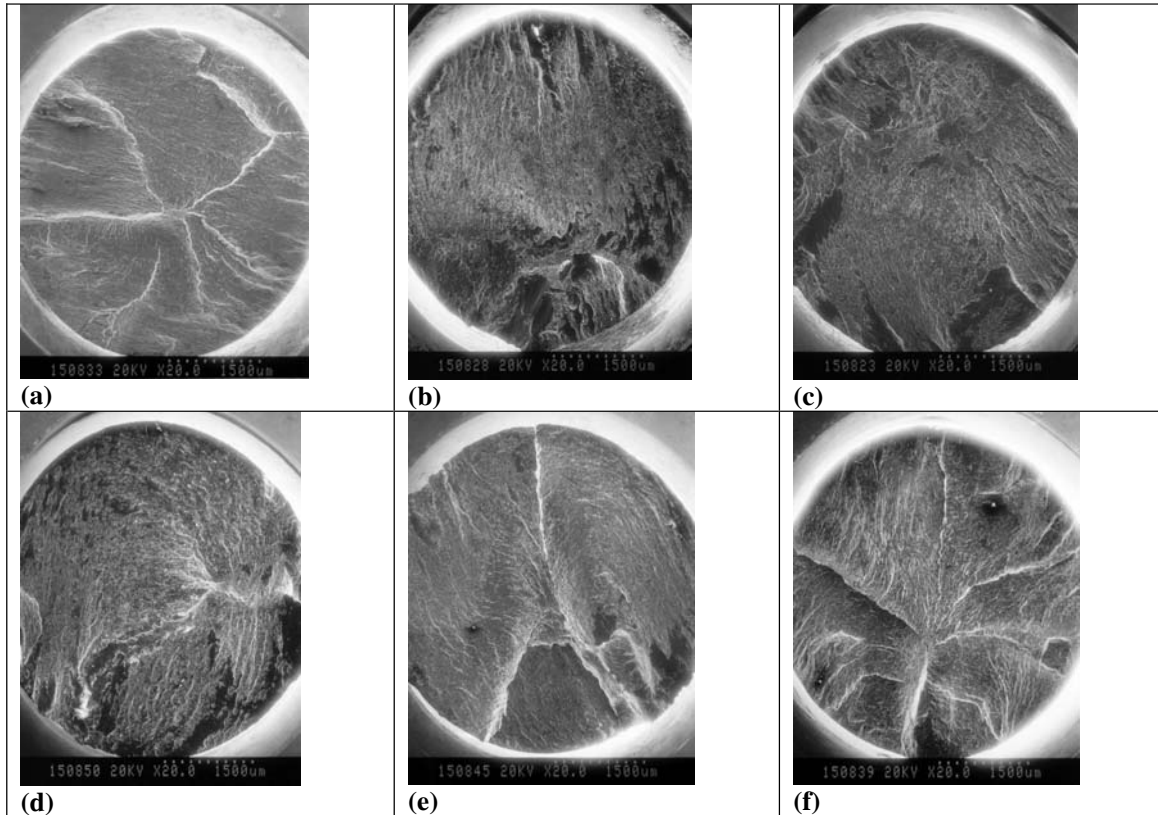
The fracture surface of AZ31 for EP condition and BB condition at different stress is shown in Fig.

Fig.4. SEM micrographs showing fracture surfaces at difference stress for EP at (a) 60MPa; (b) 80 MPa; (c) 100 MPa and BB at (d) 60MPa; (e) 80 MPa; (f) 100 MPa.

on applied stress level, above 60 MPa cracks initiate at the surface (surface fracture), while below that stress at the interior of the specimen (subsurface fracture). Subsurface fracture is a very interesting finding, which has not been recognized in Mg alloys, for both EP and BB conditions.

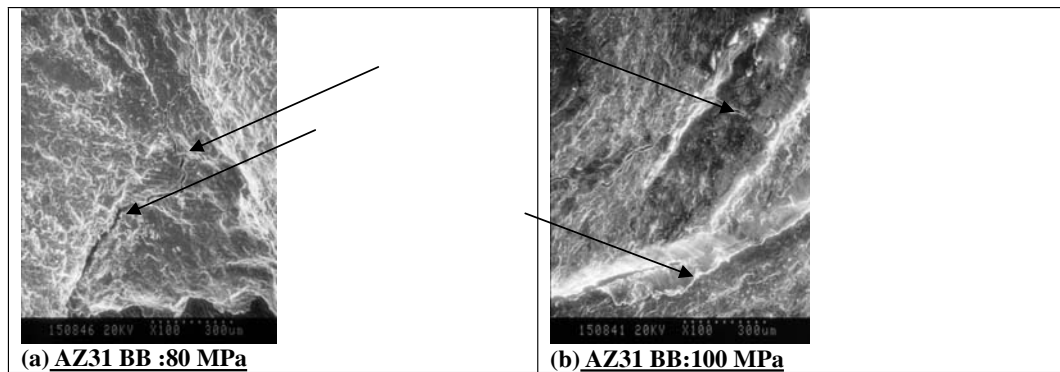
Fig. 5. SEM micrographs showing cracked surfaces at difference stress for BB at (a) 80MPa; (b) 100 MPa

The cracked line could be seen easily for higher stress for BB condition as fracture occurs in internal surface not at the outer surface as in the EP condition in Fig. 5.

4. As a result of crack initiate from the surface for EP condition it fails under lower stress than in BB condition which crack initiate internally (as surface treated by BB).
